Corrosion cracking in pipelines:

Chloride induced stress corrosion cracking (CISCC) in pipelines

Technical Paper

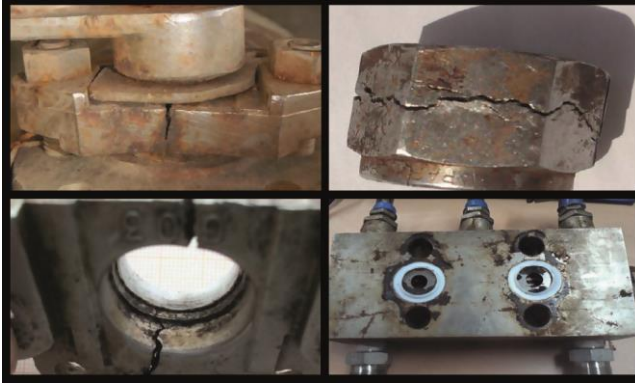
Picture 1: Corrosion cracking in pipelines
